Norfolk Island Regional Council

Norfolk Island Airport Airside Pavement Inspection

February 2017

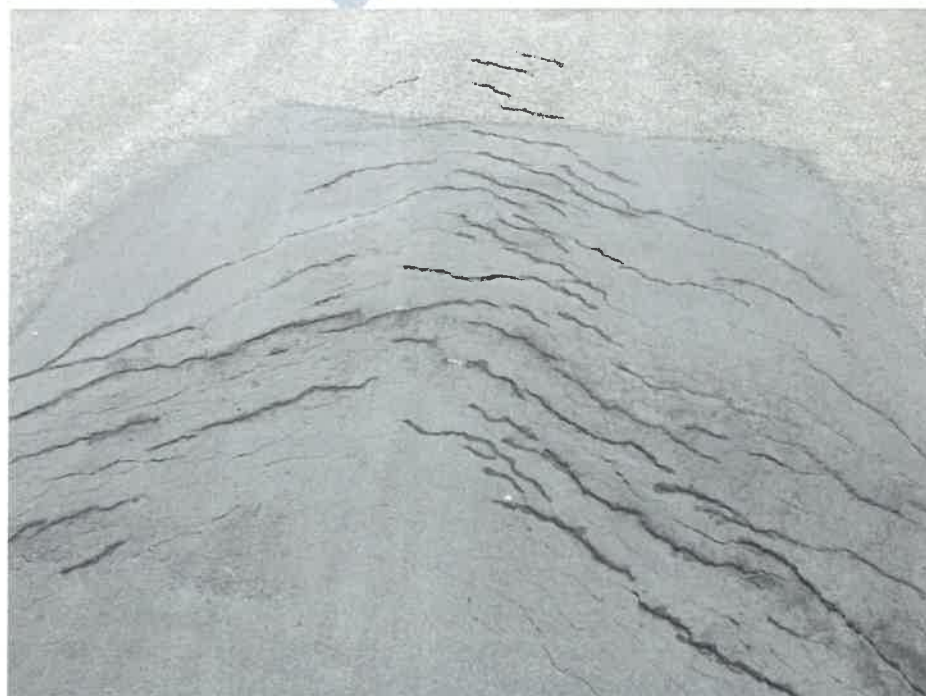
The quantum of slippage cracking in the runway end would suggest that debonding of the asphalt layers is occurring at that location.

- Lack of bond between the two asphalt layers and possibly insufficient texture for the surfacing to adhere too;
- Inadequate shear strength of the asphalt mix (usually due to insufficient depth of the overlay <50mm);
- Moisture ingress to the asphalt interface layer exacerbating the debonding process; and
- Possibly a large non-standard wheel load - C130- Hercules, C17 – Globemaster or other.

Slippage cracking is evident throughout the Runway 11 strip end (used as a turning node starter). The majority of these cracks have received some form of rubberised crack sealant and or pavecoat treatment in an aid to hold them from deteriorating further.

These cracks, combined with the dry and brittle bitumen binder of the asphalt, increases the development of FOD. If areas with slippage cracks are not repaired, the cracks may link up and pieces of surfacing may be come dislodged, causing a FOD risk.

Figure 2 Photo example of slippage cracking at the 11 turning end

The only suitable repair methodology for slippage cracking is asphalt replacement to a depth where a suitable bond is created.

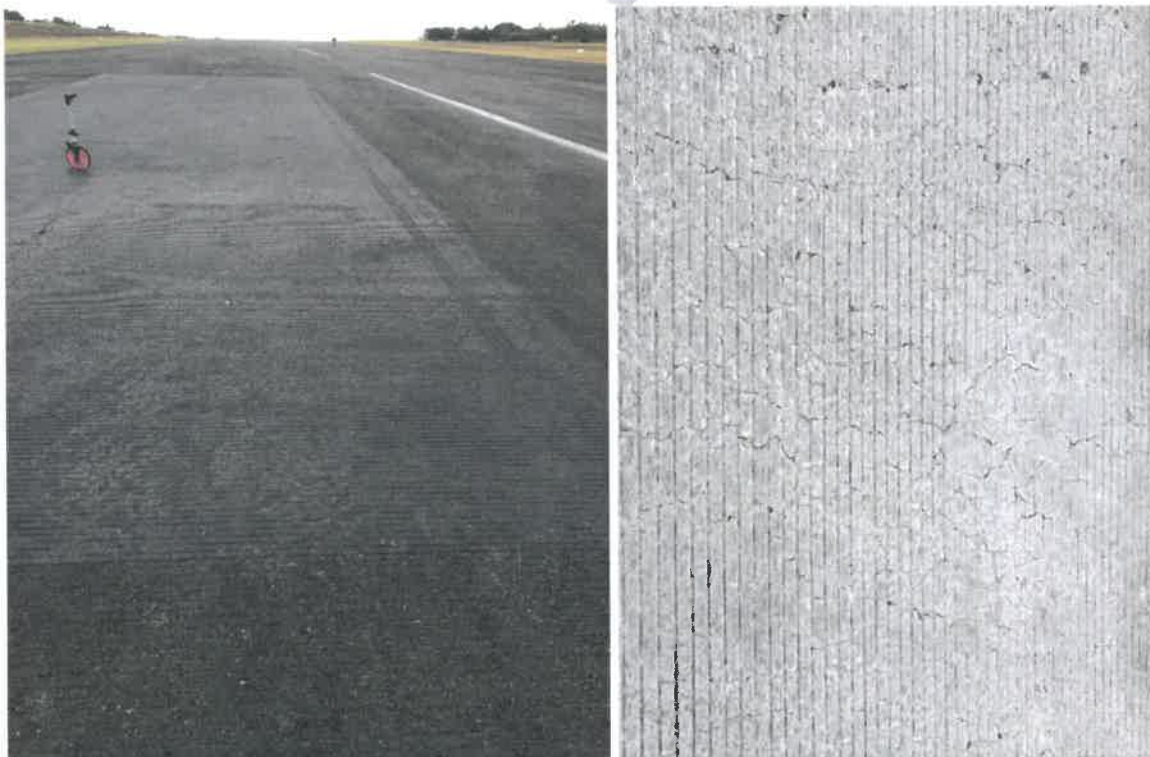
Norfolk Island International Airport has evidence of medium severity alligator cracking. Located at the 11/29 and 04/22 runway intersection the alligator cracking is located in a critical zone.

Alligator cracks allow ingress of moisture into the underlying asphalt and/or pavement layers with resulting moisture damage of underlying layers. In combination with the dry and brittle binder and ravelling, increases the development of FOD. If areas with alligator cracks are not repaired, the cracks may link up and pieces of surfacing may be come dislodged, causing a substantial FOD risk.

Figure 3 Photo examples of the medium severity alligator cracking evident at Norfolk Island runway intersection

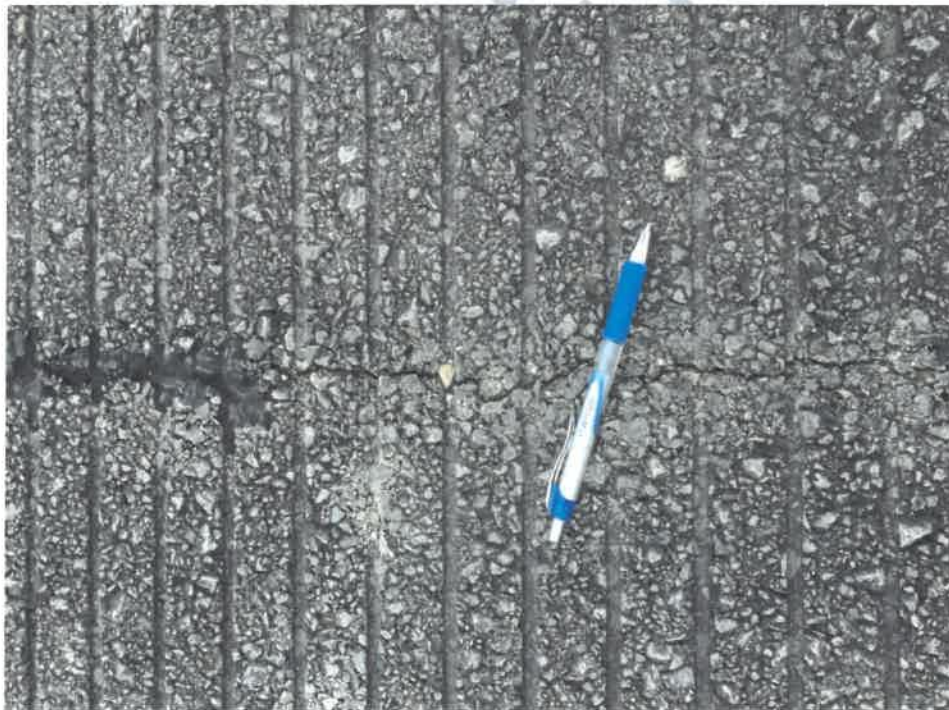
Norfolk Island International Airport has longitudinal cracking throughout the airside pavement site. Most are low in severity and cause limited FOD concern.

If left untreated longitudinal cracking allow water ingress and with repeated aircraft loading increases in severity to either a spalling crack or an alligator cracking defect. In areas of no aircraft traffic the untreated cracks progress to block cracking defects.

Figure 4 Photo example of an open and unsealed low severity longitudinal crack at Norfolk

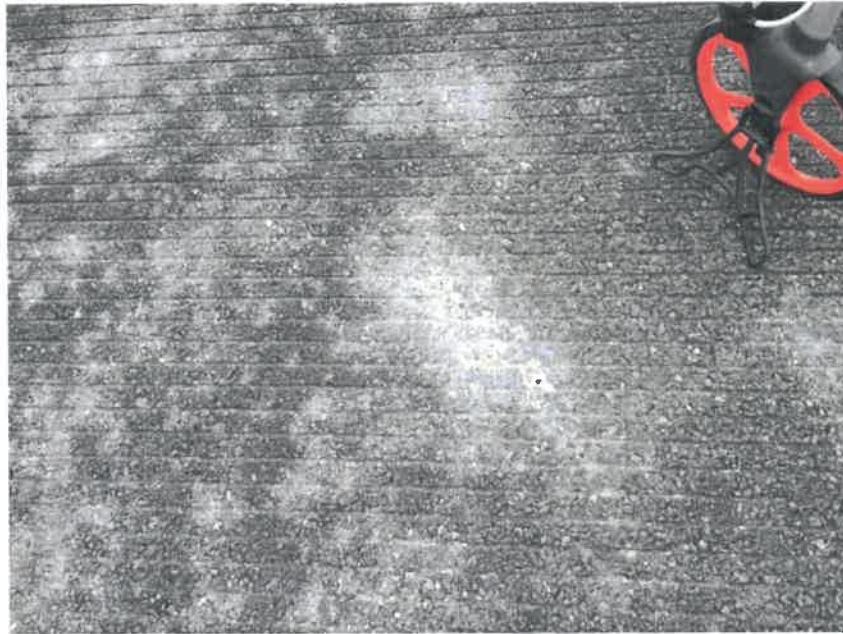
Throughout the airport site white staining exists on the asphalt surfacing. The staining is caused by a water/aggregate reaction as water penetrates voids in the asphalt surfacing.

Figure 5 Photo example of white staining at Nelson Airport

The white staining present at Norfolk Island is high-volume which algae and detritus build-up occurring in outer runway edge locations where the staining and moisture collection is at its worst.

Where possible, areas of high air voids should be surfaced with a sealing product to improve water proofing and to reduce the rate of deterioration.

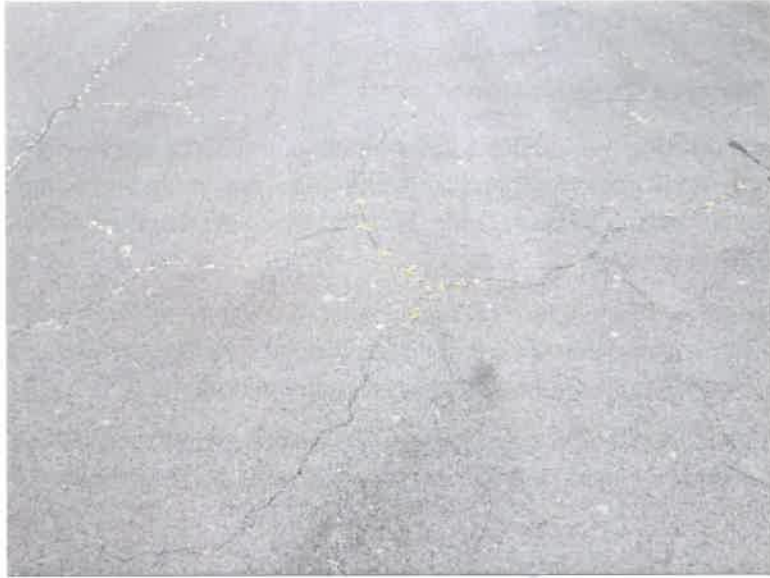
The full extent of the 500m of 04/22 runway has low severity block cracking throughout. Weed control is a constant maintenance item for the airport personnel with the block cracks harbouring detritus upon which weeds grow from.

With only light General Aviation aircraft using the crosswind runway the block cracking defect causes minimal to no FOD threat to passenger services.

Figure 6 Photo example of block cracking at Norfolk Island

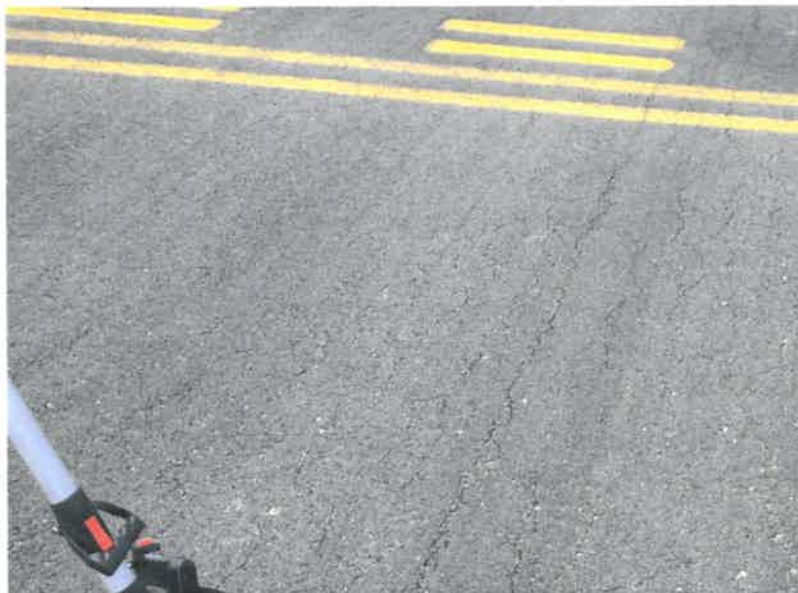
Structural distresses in the form of alligator cracking are present in numerous locations along the length of the taxiway. The majority are present at the Runway 04/22 end of the taxiway.

In all locations the alligator cracking has progressed to medium severity and remedial treatment is necessary in the short term prior to the defect becoming an operational FOD related concern.

Figure 7 Photo example of alligator cracking on the taxiway at Norfolk Island

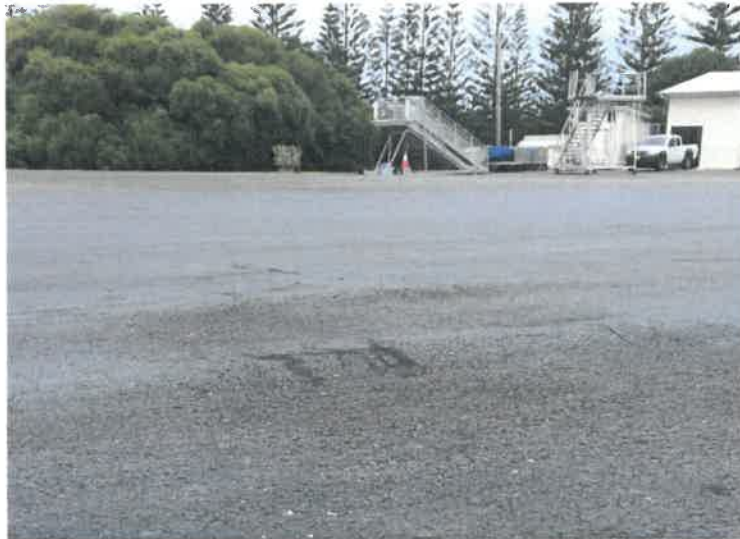
The depressions evident on the passenger apron are considered to be in excess of 60mm in depth thus are high severity.

Asphalt generally lacks the shear capacity to cater for the high point loads of Code C aircraft tyre pressures and vertical pavement deformation under repeated or long duration traffic loading is a common occurrence.

Figure 8 Photo example of depressions at Norfolk

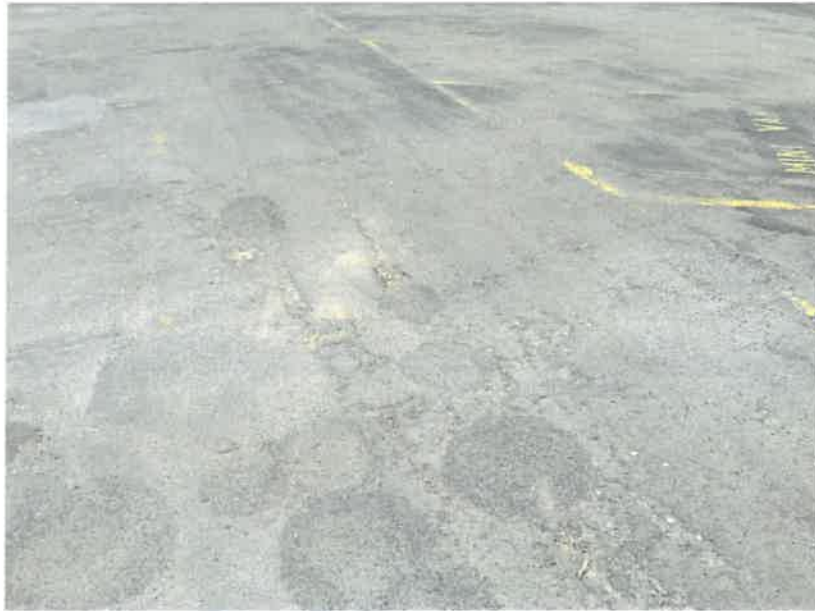
The area to the east of the car park is at a higher geometric topography to the rest of the car park and as such minimal distressed from moisture ingress but is suffering from aggregate ravelling and chip loss.

In the western end of the car park, the lower topographic end of the car park, which has numerous drainage infrastructure items present, the surfacing is suffering from excessive ravelling, exposed basecourse aggregates, potholes and poor ride quality evident throughout.

Figure 9 Photo example of landside car park surfacing quality

The car park surfacing is generally in a POOR condition and some form of resurfacing should be sought with any works package that may assembled by NIRC.
