Norfolk Island Environmental Assessment

June 2021

Scope

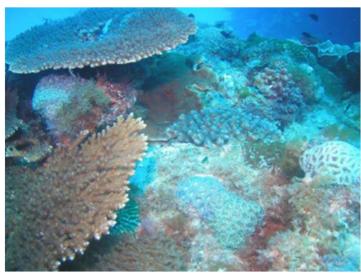
Emily Bay Plate Coral 1992 showing high coral cover and rich diversity in coral species and small fish (Source: Mr Jack Marges)

Emily Bay plate coral 2016, showing a decline in coral diversity and cover and a complete absence of small fish (source: Mrs Corrine Parsons)

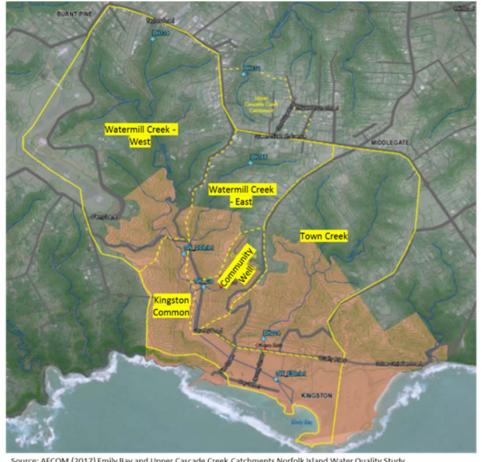
Source: AECOM (2017) Emily Bay and Upper Cascade Creek Catchments Norfolk Island Water Quality Study, Prepared by AECOM Australia for Norfolk Island Regional Council (REF: 60531847)

Location	Land Use	Area (ha)
Watermill Sub-catchment West	Rural Residential	105
Watermill Sub-catchment West	Agricultural	45
Watermill Sub-catchment West	Forest	28
Watermill Sub-catchment East	Rural Residential	20
Watermill Sub-catchment East	Agricultural	21.7
Watermill Sub-catchment East	Forest	20
Kingston Commons Sub-catchment	Forest	45.1 40
Kingston Commons Sub-catchment	Agriculture	
Community Well Sub-catchment	Agriculture	23.6
Town Creek Sub-catchment	Agriculture	80
Town Creek Sub-catchment	Forest	59
Watermill Creek Catchment	487.4
