## WATER QUALITY IN THE KAVHA CATCHMENT

**Report Prepared by**

**P.J. Wilson**

**The Norfolk Island Regional Council**

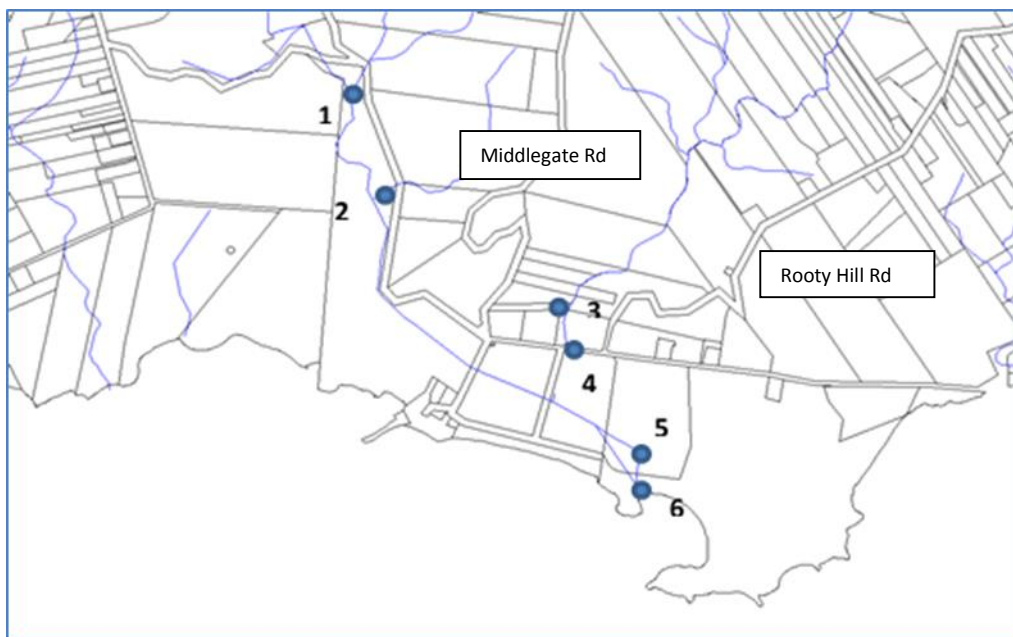
Figure 2.1: Sample Locations in the KAVHA Catchment

The location of the six sample sites across the KAVHA Catchment are shown in **Figure 2.1**. The creek running from Site 1 is known locally as Watermill Creek and Site 3 and 4 is known as Town Creek. An aerial view of the site is shown in **Figure 2.2**.

The sample site location codes shown on Figure 2.1 represent;

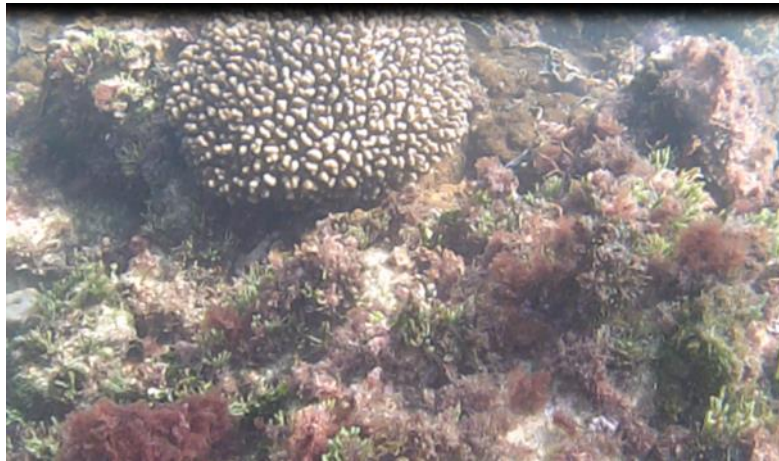
Figures 3 and 4 show the coral reef off Salt House point in April 2016. Rich and luxuriant algal growth on and around the dead coral is evident. The introduction of high levels of phosphorous and nitrogen is known to cause bleaching and death in coral and to enhance algal growth (AIMS 2017, Vega Thurber *et al* 2014, D'Angelo and Wiedenmann, 2014).

**Figure 5.1:** Dense algal growth adjacent the Salt House (source Mrs Corrine Parsons, 2016)

The loss of total coral cover and diversity is demonstrated in Figures 5.1 -5.6. Images made in Emily Bay in 1992 show the reef was characterised by a diverse range of vibrant coral and marine species with limited algae growth (Figure 5 and 7). Images from the bay taken in 2016 show a considerable decrease in coral cover and diversity and a substantial increase in algal growth relative to 1992.

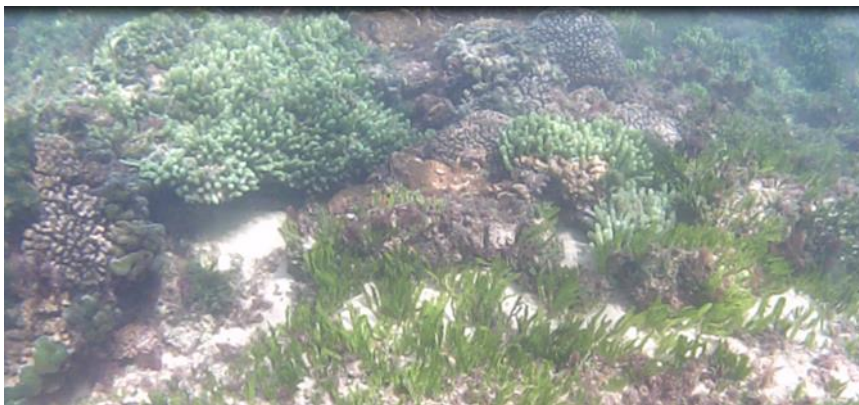
**Figure 5.2:** Image shows limited coral amongst dense and luxuriant algal and seagrass growth (source Mrs Corrine Parsons, 2016)

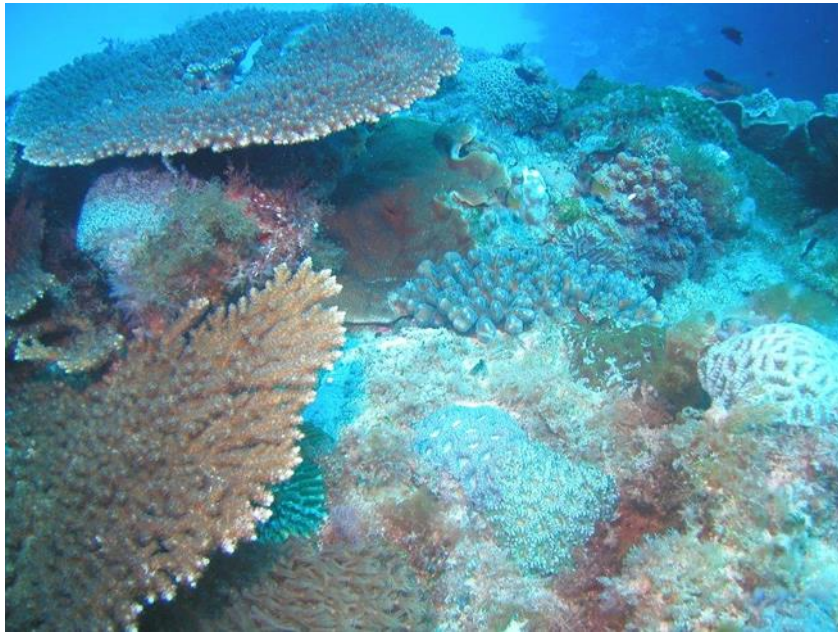
**Figure 5.3:** Emily Bay Plate Coral 1992 showing high coral cover and rich diversity in coral species and small fish (Source Mr Jack Marges)

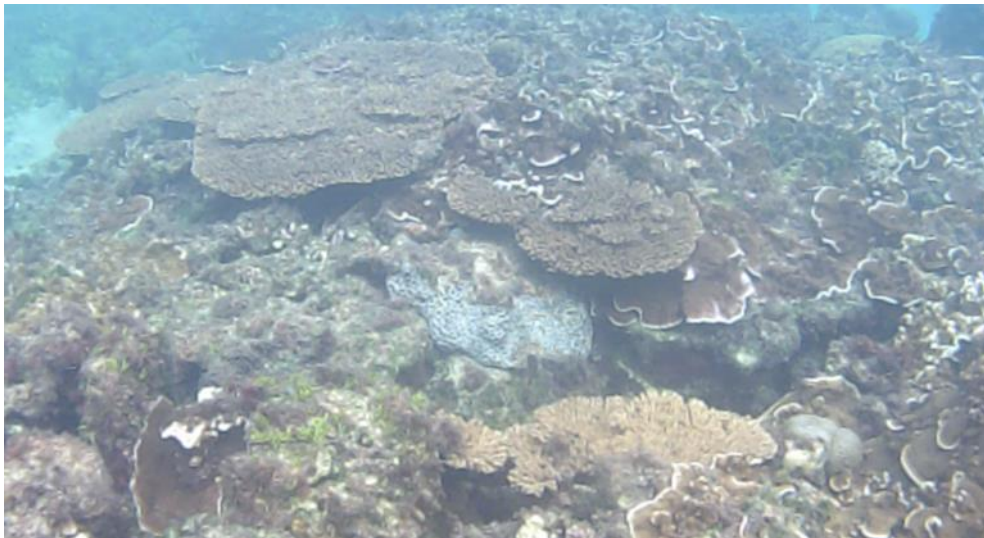
**Figure 5.4:** Emily Bay plate coral 2016, showing a decline in coral diversity and cover and a complete absence of small fish (source Mrs Corrine Parsons)

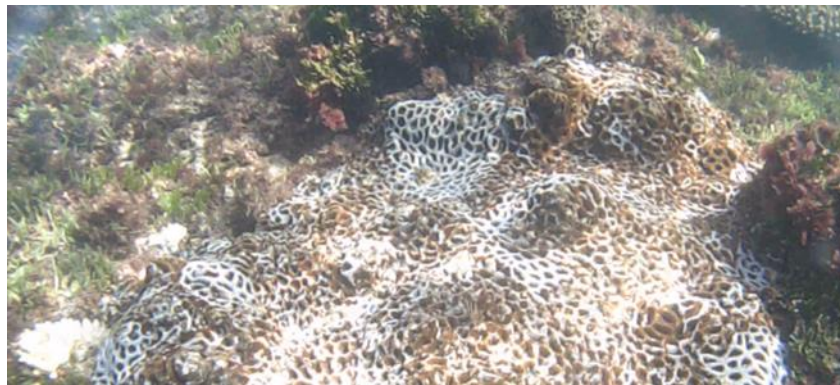
**Figure 5.6:** Image from 2016 showing dead coral being overgrown by algae (Source Corrine Parsons 2016)

The ongoing degradation of the Emily Bay lagoon ecosystem is clearly obvious and based on the rate of coral loss and algal growth in Emily and Slaughter Bay, the entire ecosystem could be lost within 5 – 10 years (Pendoley Environmental, 2015). If 100% of the coral is lost, recovery of the ecosystem will be delayed by the lack of immigration of coral spawn from external reef systems (e.g. Lord Howe) due to the isolated nature of Norfolk Island. However if the discharge of fresh water and nutrients into the bay is stopped soon, the system is expected to show signs of recovery within 1 year (Vega Thurber *et al* 2014).
