## DEGRADED STORMWATER DRAIN AT AIRPORT CAUSES SUBSIDENCE

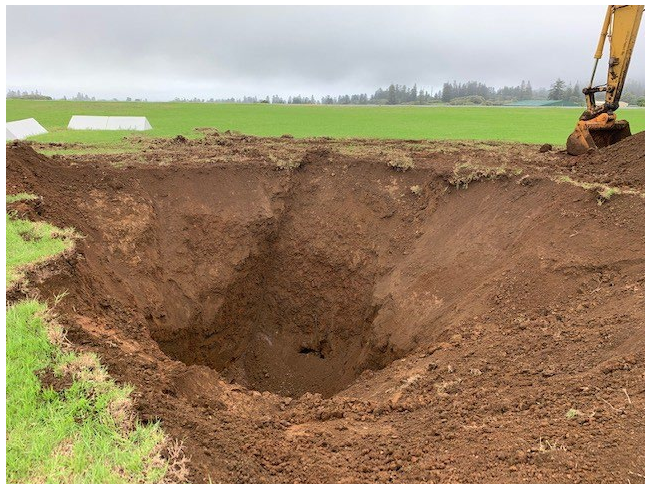
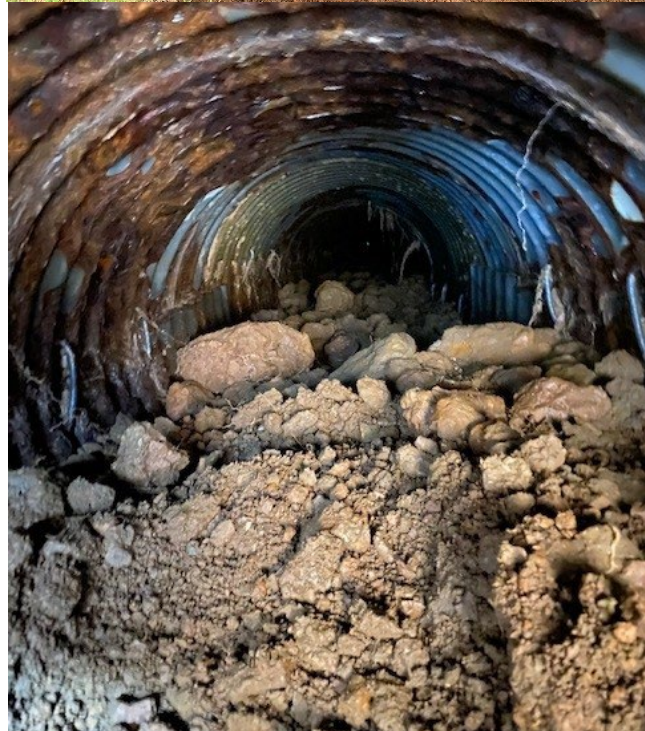
Land subsidence was discovered on Wednesday at the airport grounds and is currently under repair.

Initial assessment and excavation of the hole showed the underground area was eroded due to a failed corrugated stormwater drain that was full of large debris including rocks and general earth materials.

We are currently undertaking works to fix the stormwater pipe as best we can in anticipation of the upcoming rain event.

To prevent this from happening in the future, we will build a retention basis and redivert the water through a separate, open stormwater drain, to avoid the use of the existing degraded drain. However, we'll start this process after the upcoming anticipated rainfall.
